**Flood Control Project Maintenance
Levee Inspections****LMA District Cover Sheet
Spring 2015 Levee Inspection Results****Reclamation District No. 0369 Libby McNeil**

Levee Inspection Report By Mile - Spring 2015

Waterway	Bank	Unit Miles	Inspection Start/End	Inspector
Unit No. 01 Steamboat Slough	Left	0.78	04/16/2015 04/16/2015	Herman Phillips

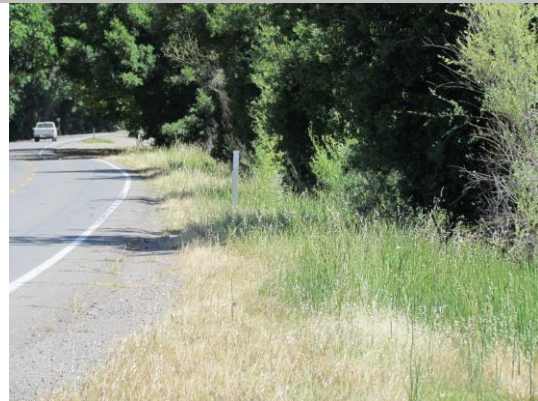
Photo 1 of 1 : SP_2015_RD0369_207_18_20150527_00001.jpg

LM Start	0.02	Rating **	M	Issue No.	18
LM End	0.09	Issue Type +	Ma	Location *	WS
Category	Earthen Levee			GPS Latitude/Longitude	
				Start	End
Item	Vegetation			38.258745 °	38.257910 °
				-121.517563 °	-121.516560 °
DWR ID	DWR_RD0369_01_s_2015_18				
Action/Comments					
Remove the wild growth other than native grasses from the levee slopes.

Looking downstream at the waterside levee shoulder.

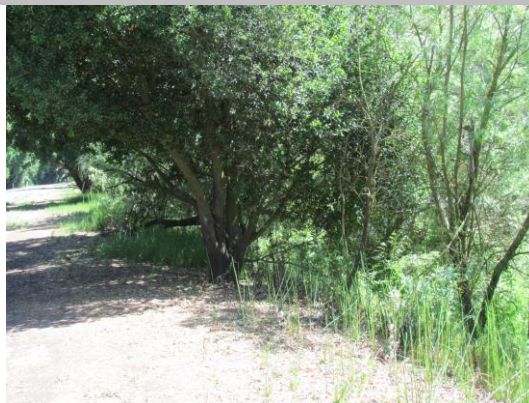
Photo 1 of 1 : SP_2015_RD0369_207_30_20150527_00002.jpg

LM Start	0.26	Rating **	U	Issue No.	30
LM End	0.33	Issue Type +	Ma	Location *	WS
Category	Earthen Levee			GPS Latitude/Longitude	
				Start	End
Item	Trim / Thin Trees			38.256245 °	38.255532 °
				-121.514352 °	-121.513515 °
DWR ID	DWR_RD0369_01_s _ 2015_30				
Action/Comments					
Trim and thin trees to allow visibility of the ground and room to flood fight.					
Inspector Comments: Trim and thin out the wild growth of young trees.

Wild growth of young trees on the waterside blocking the view of slope.

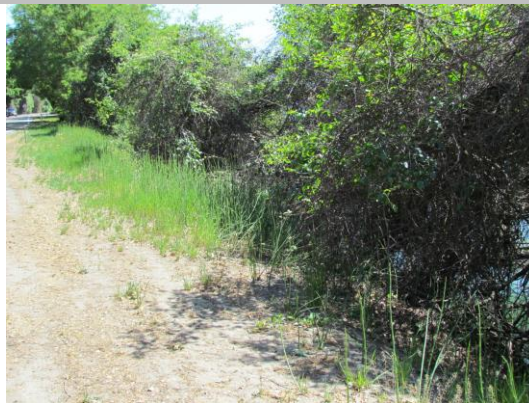
Photo 1 of 1 : SP_2015_RD0369_207_31_20150527_00003.jpg

LM Start	0.40	Rating **	U	Issue No.	31
LM End	0.47	Issue Type +	Ma	Location *	WS
Category	Earthen Levee			GPS Latitude/Longitude	
				Start	End
Item	Trim / Thin Trees			38.254708 °	38.253917 °
				-121.512727 °	-121.512063 °
DWR ID	DWR RD0369 01 s 2015 31

Woody tree growth on the waterside blocking the view of the slope.

Action/Comments					
Trim and thin trees to allow visibility of the ground and room to flood fight. Inspector Comments: Trim the trees so you can see the slope underneath.

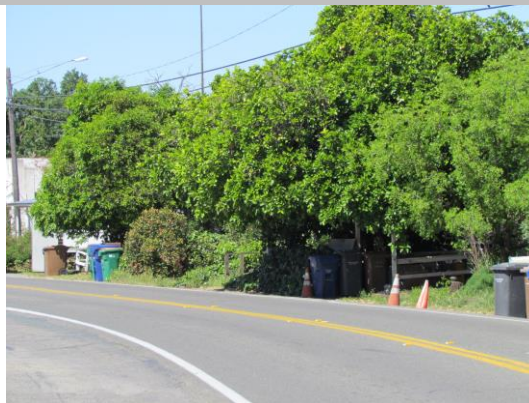
Photo 1 of 1 : SP_2015_RD0369_207_32_20150527_00004.jpg

LM Start	0.72	Rating **	U	Issue No.	32
LM End	0.77	Issue Type +	Ma	Location *	LS
Category	Earthen Levee			GPS Latitude/Longitude	
				Start	End
Item	Trim / Thin Trees			38.250523 °	38.249923 °
				-121.510167 °	-121.509987 °
DWR ID	DWR_RD0369_01_s_2015_32				
Action/Comments					
Thin trees to allow visibility of the ground and room to flood fight. Inspector Comments: Thin out and trim up the trees on the landside levee section. The slope cannot be viewed.

Looking upstream on the landside woody tree growth blocking the view of the levee slope and shoulder.
